Mine Name: Dragon Mine

Operator Name: Applied Minerals

Inspection Report Minerals Regulatory Program April 17, 2012

Permit Number: M/023/0080

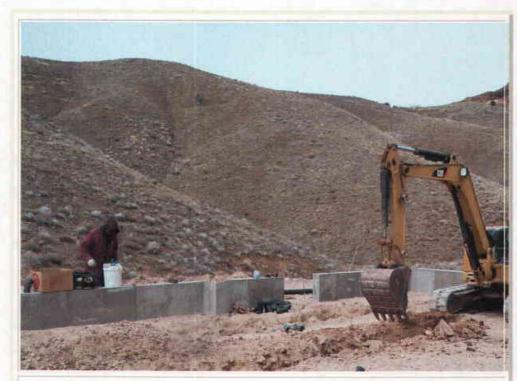
Construction of new building

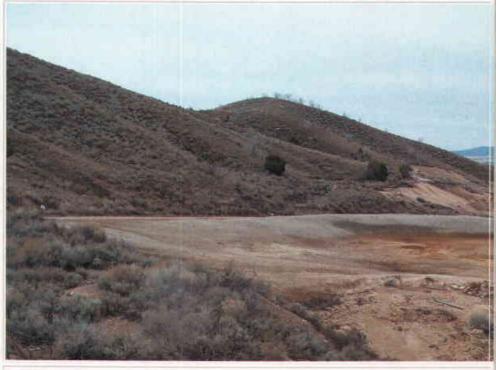
The site has a sediment pond that has not yet discharged. The pond is designed to keep runoff from the site from discharging off site.

Sediment pond

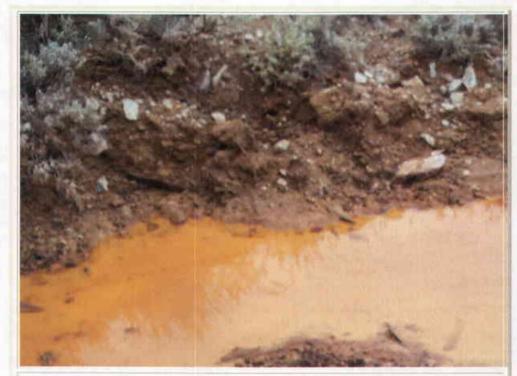
There are old mine working on the property that discharge water. Some of the water has a red color that most likely comes from the iron in the rock.

Red colored water from old mine workings

The Division should continue to monitor the site.

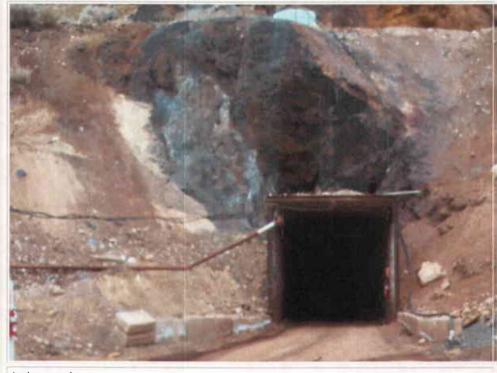
The Permittee does take steps for limit access to the site. There is active underground mine/exploration. There are ventilation shafts

Active portal
